National Dam Inspection Program. Lake
Rene Dam (Lake Rene) (NDI PA-426, DER
17-102), Ohio River Basin, Tributary of
Narrows Creek, Clearfield County,
Pennsylvania. Phase I Inspection Report.

PHASE I REPORT
NATIONAL DAM INSPECTION PROGRAM

NAME OF DAM: Lake Rene Dam
STATE LOCATED: Pennsylvania
COUNTY LOCATED: Clearfield County
STREAM: Narrows Creek, a tributary of Sandy Lick Creek
DATE OF INSPECTION: April 2, 1979 and May 4, 1979

LAKE RENE DAM
NDI I.D. NO. PA-426
APRIL 2, 1979

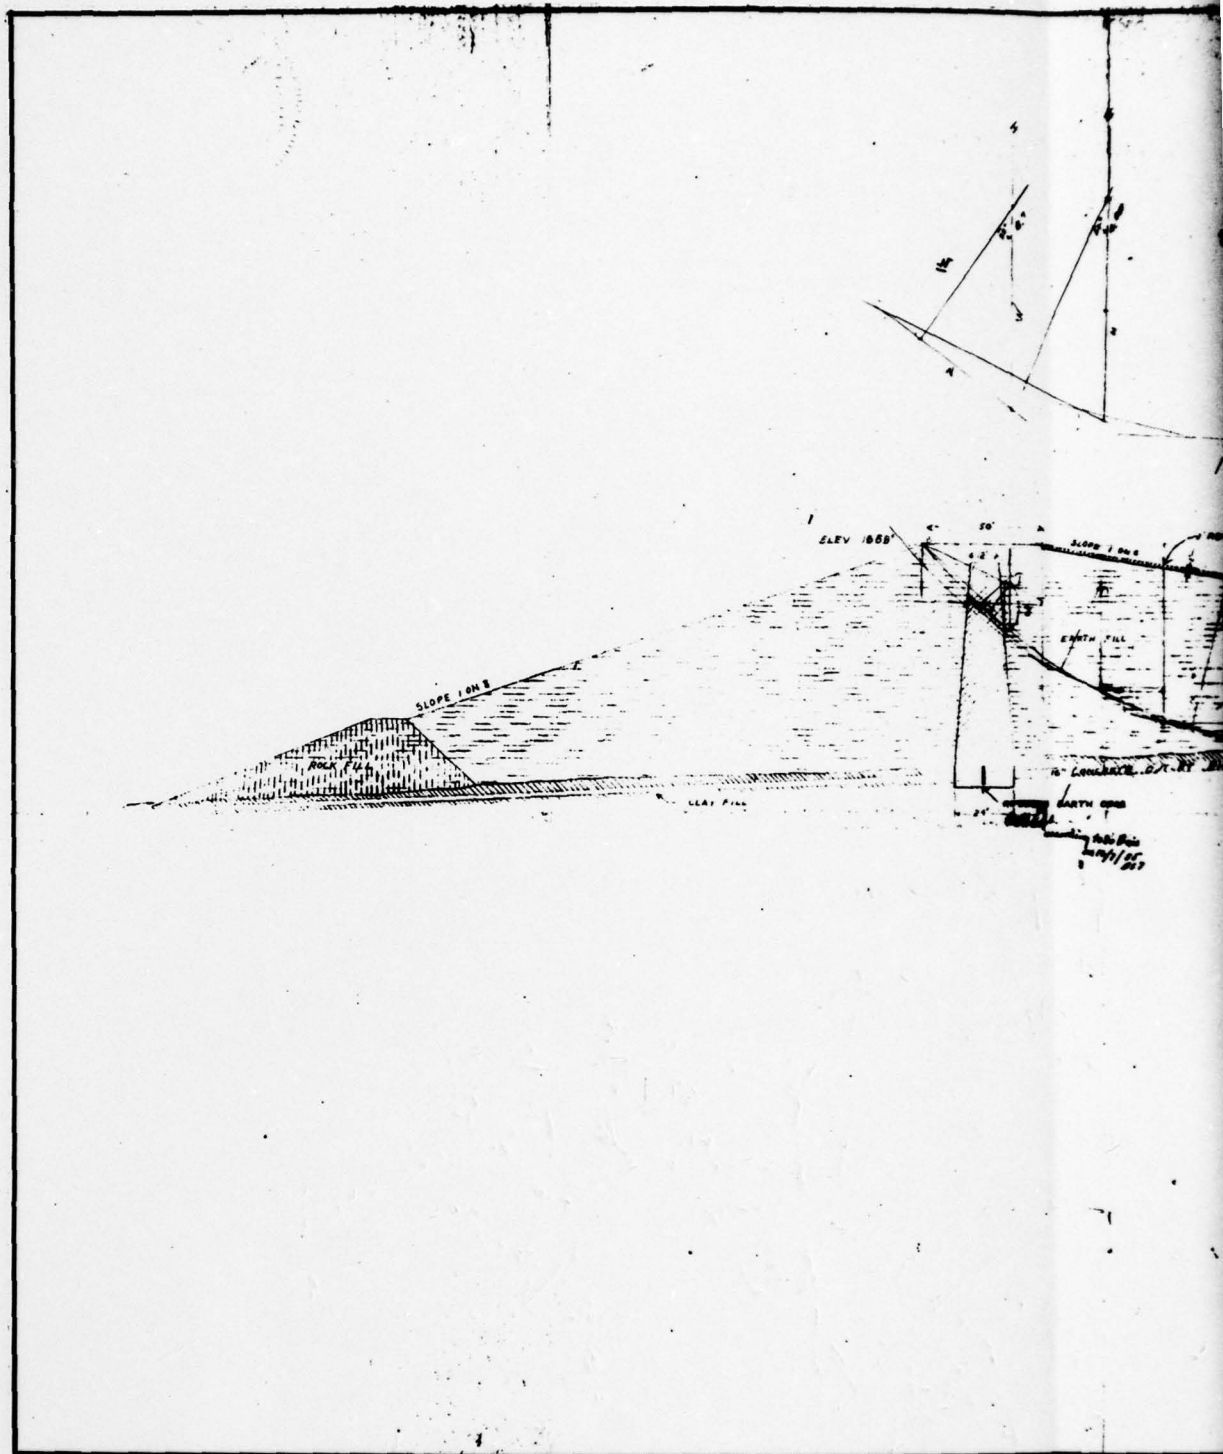
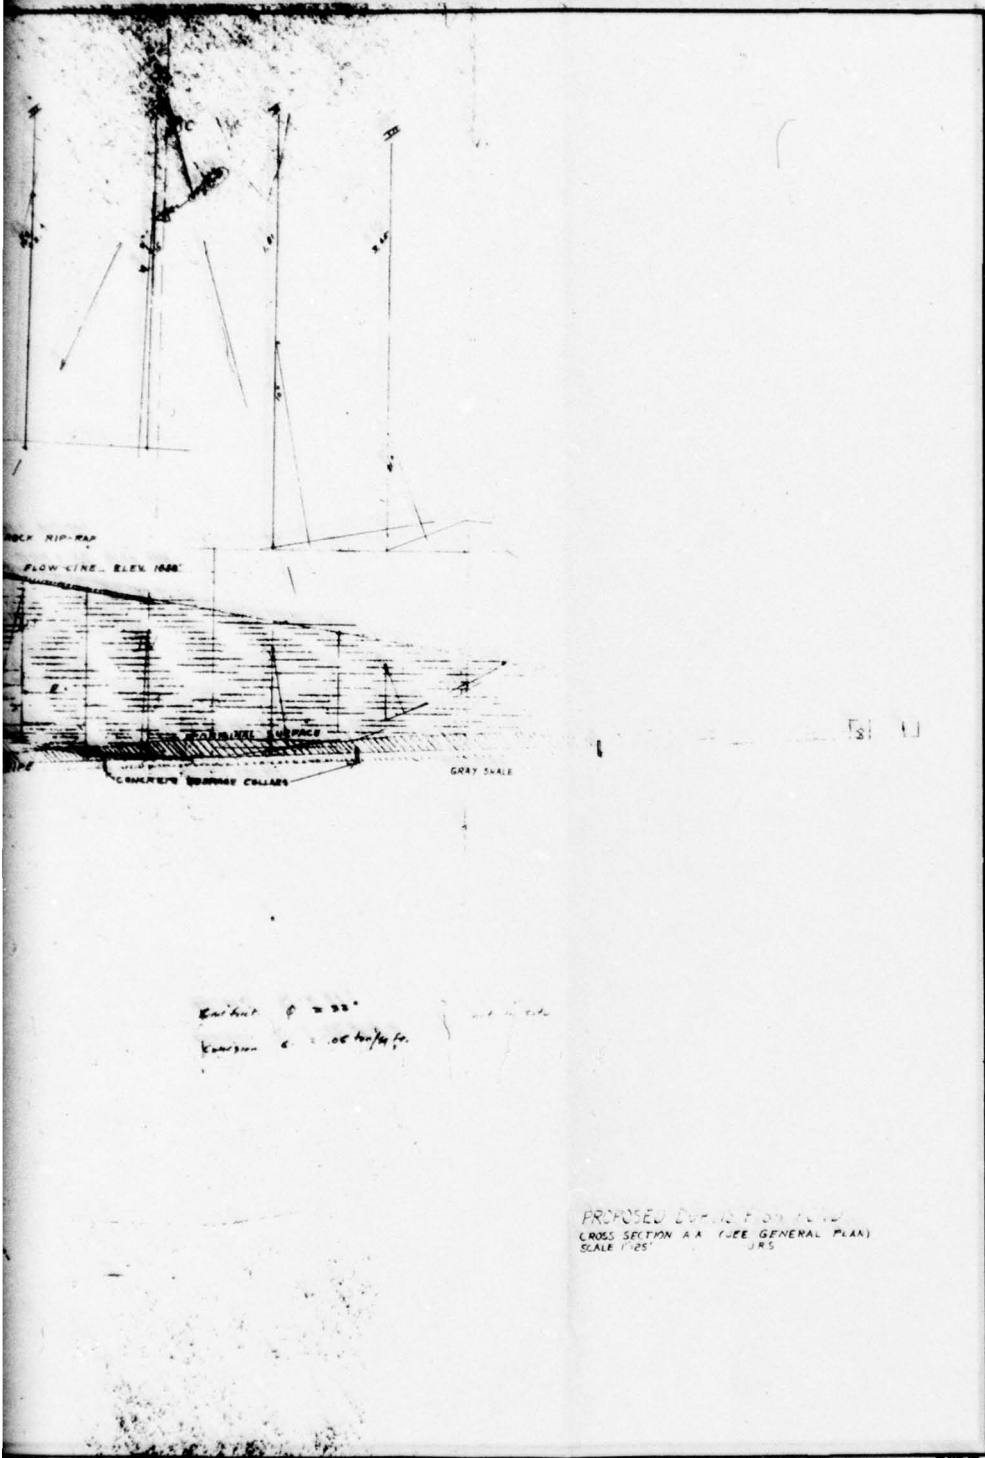
PLATE 3

(1) Embankment. As shown in a design sketch (Plate 2), the dam is a zoned embankment (Plate 3) consisting of a central impervious core with shale sections downstream and upstream and a rock-fill section at the toe of the downstream slope. The impervious core section is shown to be 24 feet wide at the base of the dam and 12 feet wide at about Elevation 1660. The same drawing shows the downstream face of the dam to have a 3H to 1V slope, while the upstream face was shown to have a slope 6H to 1V. However, field observations suggest that the dam was not constructed according to this design sketch. The downstream face of the dam was found to be much steeper than 3H to 1V. No evidence of a rock fill at the downstream toe of the dam was found. As it exists, the downstream face of the dam is 1.3H to 1V from crest elevation to a point approximately 15 feet below the crest, 2H to 1V for another 15 feet and 3H to 1V for the rest of the downstream slope. The portion of the upstream slope above normal pool elevation was found to have a slope of 2.5H to 1V.

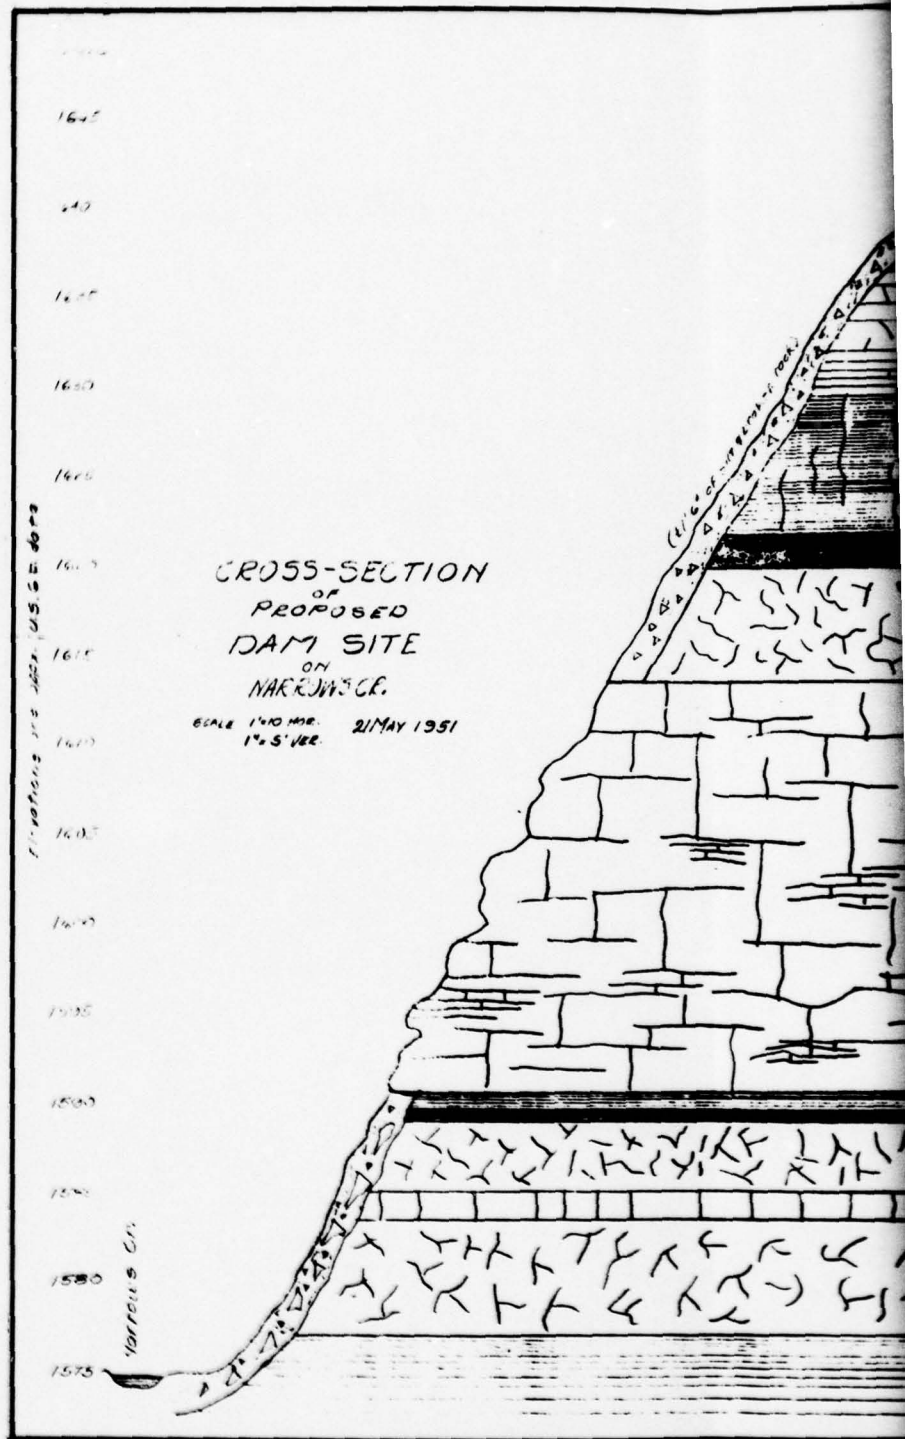
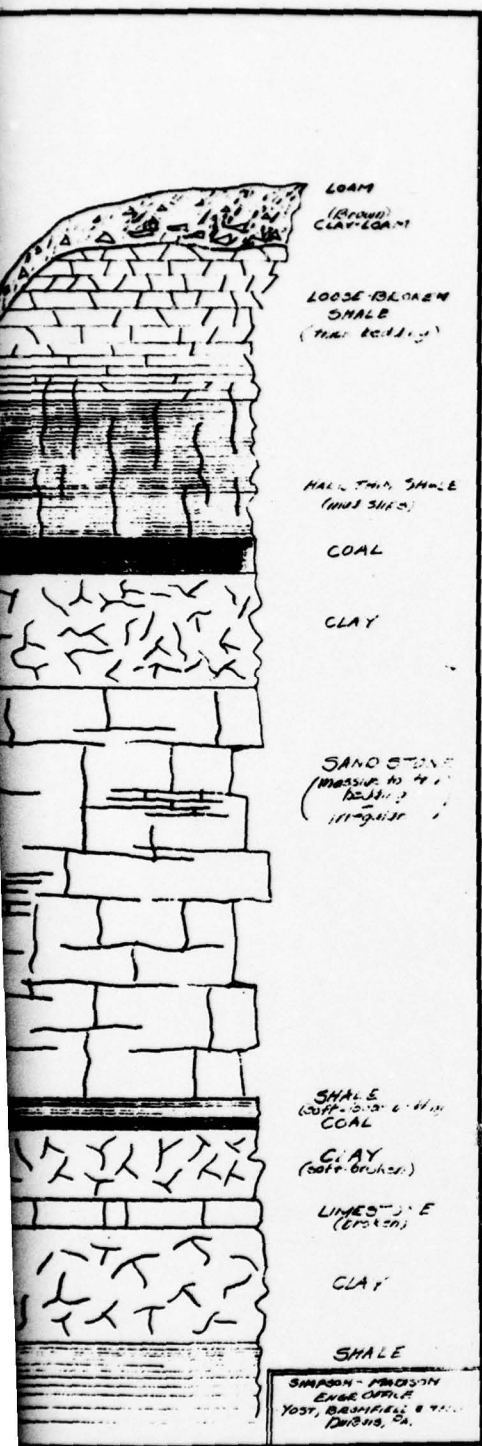
PLATE 5

(2) Embankment. Very limited engineering data are available on the design of the embankment. As shown on Plate 4, it appears that at least two borings were drilled for subsurface investigation. Plate 5 illustrates a geological profile for one of the abutments of the dam. However, the source of this information was not identified. A laboratory soils testing report prepared by Pittsburgh Testing Laboratory of Salt Lake City, Utah, indicates that laboratory soils tests included classification, compaction, and direct shear tests. The grain size distribution curve indicates that the material ranges from gravel to clay size with approximately 60 percent passing a 200 sieve. The liquid limit of the material was reported to be 32.5 percent with a plasticity index of 8. Direct shear tests were consolidated-undrained and the results were internal friction angle, $\phi = 32$ degrees, cohesion, $c = 0.05$ tons per square foot. As shown on Plate 2 and on other drawings included in the files, it appears that an attempt was made to analyze the stability of the slopes of the dam. However, no formal calculations or results of calculations were reported.
